Automatic Compression Release

Pat Dexter

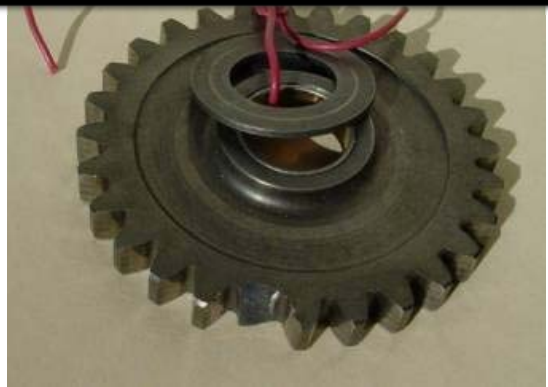
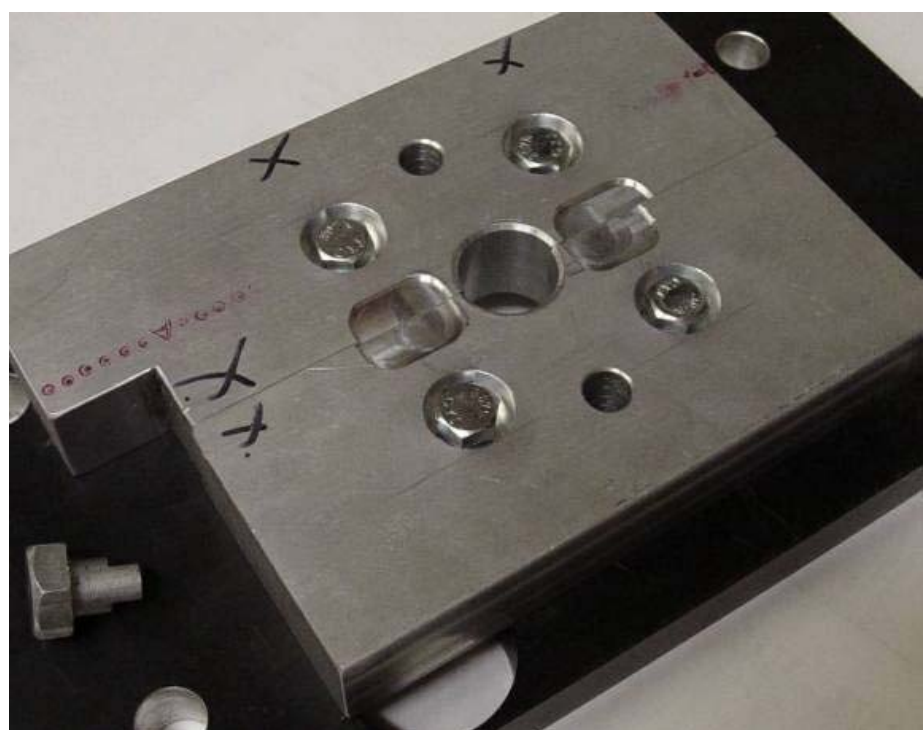
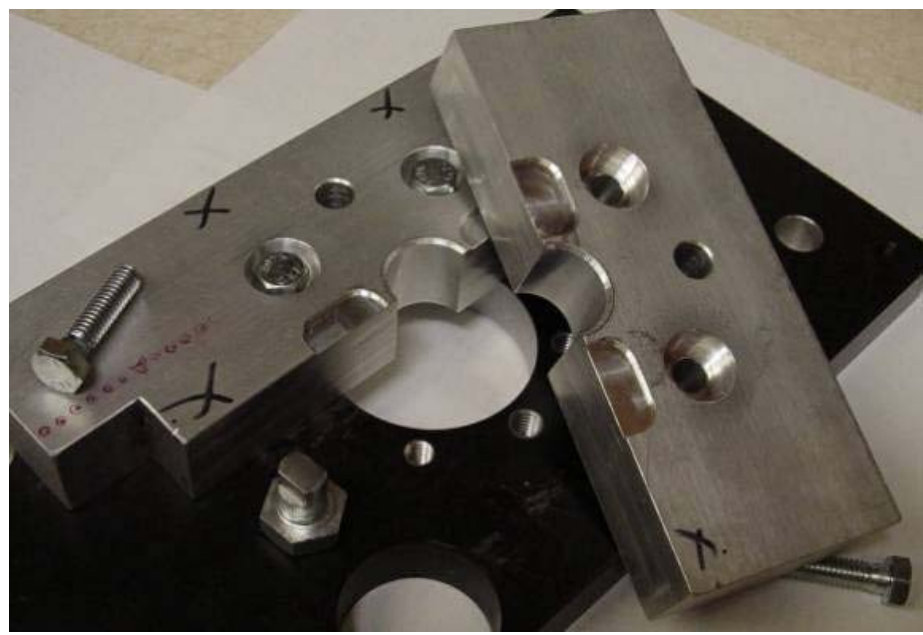
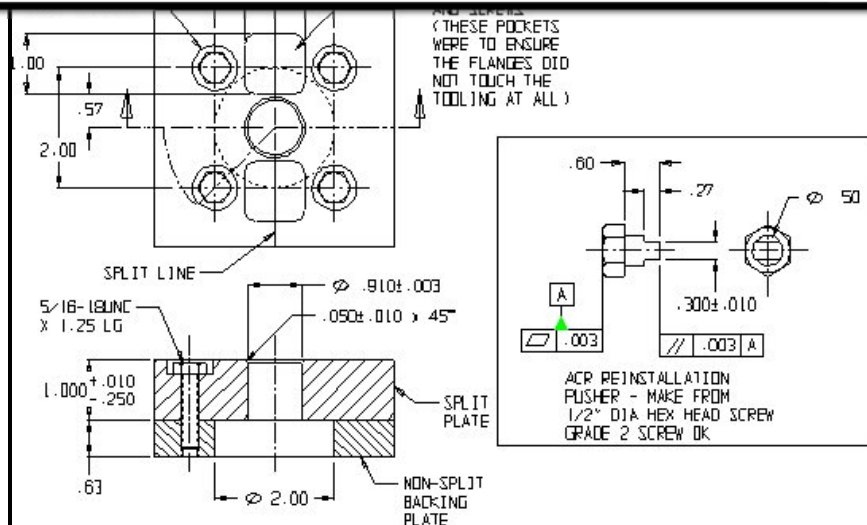
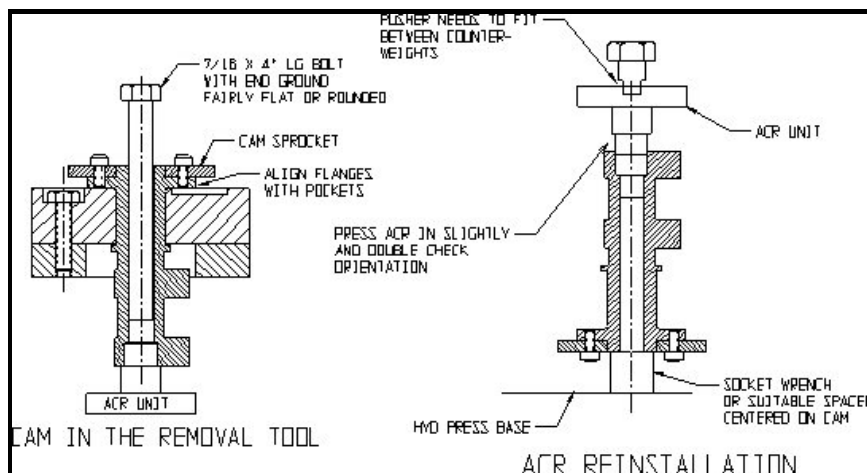
7. Using my fixture or your own (see drawings), press off the ACR. NOTE: Make sure to catch it from falling to the ground.
8. Remove the fragile spring from the ACR.

9. Clean the mating surfaces of both the ACR mechanism and the camshaft prior to reassembly. Put a thin layer of blue or red Loctite on the mating surfaces and reassemble the ACR and cam with the new alignment marks lined up. Use the special pushing tool to press the parts together, making sure that the ACR doesn't get cocked too much and double check the alignment mark location. Make sure the parts are seated all the way. Clean off any excess Loctite from the outside and deep inside the cam.
